Ute Mountain Ute Tribe  
Nonpoint Source Assessment  
for the  
Ute Mountain Ute Reservation of Colorado,  
New Mexico and Utah

**2005 Revision**

Prepared by Scott Clow, Water Quality Specialist, Ute Mountain Ute Tribe  
And *Daniel B. Stephens and Associates, Inc.*

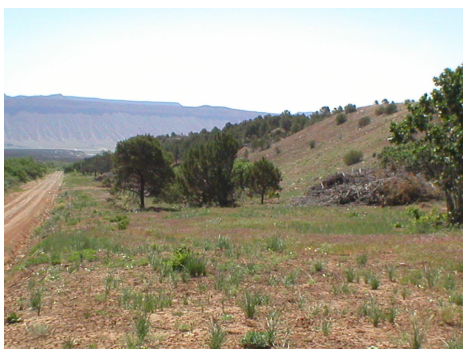
On left, newly planted native grasses (competing with cheat grass) on Special Studies Project—note slash pile to be burned during wetter conditions and steep hill with moderately successful seeding. Previously clear-cut steep hillside was not part of the fuels reduction project, but it was also seeded to prevent erosion. On right, Project map for seeding done with CWA Section 106 Special Studies \$ to prevent soil erosion after fuels treatment

One project undertaken in 1999 was to plug an old well that was adding approximately 1 ton of salt per day to the lower San Juan River watershed. The well was plugged using CWA Section 106 Special Studies funding, and the salt load was removed from the system. Another project undertaken in 2002 was to reduce erosion in the greater Towaoc, Colorado area, particularly where a fuels-reduction, forest-thinning project had been undertaken. CWA Section 106 Special Studies funds were used to purchase grass seed in order to seed the disturbed area to stabilize soils and prevent sediment movement. Despite drought conditions, the grasses took hold and the project was successful.

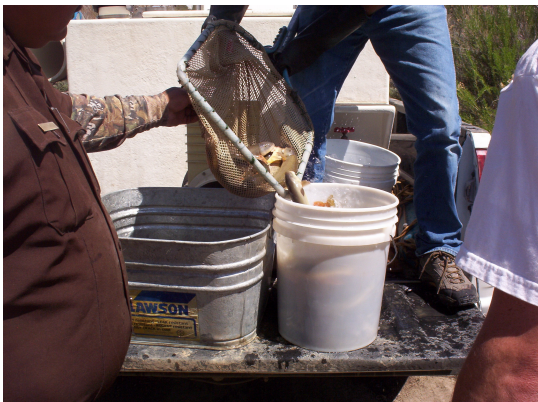
Transferring flannel mouth suckers

A partnership with the Colorado Division of Wildlife, the Tribe's Brunot Wildlife Department and Environmental Programs Departments, and Mesa Verde National Park has provided a significant ecological restoration to the Mancos River Watershed. The combination of massive, severe-intensity forest fires in the watershed in 2000 and a 5-year drought caused the demise of

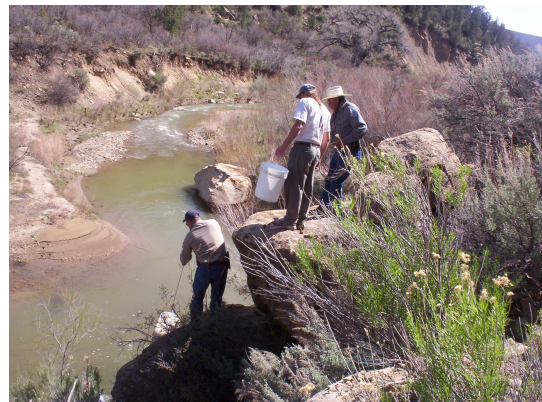
Reintroducing fish with Tribal/State team work

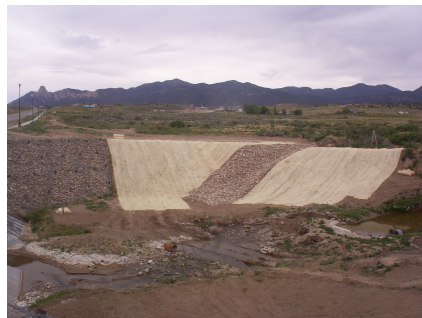
Navajo Wash erosion project

Another project was undertaken in May of 2004 to prevent further erosion and improve aquatic habitat in Navajo Wash in Towaoc, CO. This project involved grading eroded slopes around the bridge that crosses the stream in Towaoc; seeding the disturbed area; installing matting to hold the sloped banks and seed in place until it is sufficiently vegetated. In 2005, trees will be planted along the stream to create shade and enhance aquatic habitat. Rocks were also placed around the project area to exclude recreational vehicles and trucks from causing further disturbance and erosion.

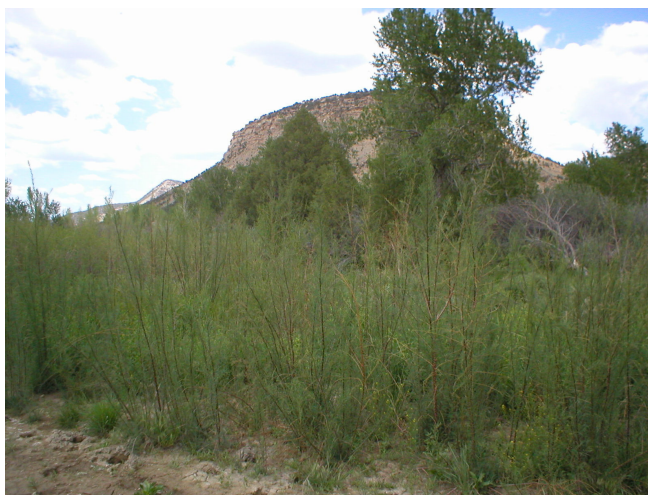
Tamarisk (salt cedar) in Mancos Canyon

Tamarisk (salt cedar) removal and treatment has been undertaken in the Mancos River Canyon. A small (4-5 acre) project was undertaken in 2003, utilizing Bureau of Indian Affairs weed control funding, to cut and treat tamarisk at the northern boundary of the Reservation. The project was very successful, and another project was funded for 2004-2005. This will cut and treat another 6-10 acres directly adjacent to the first project. A larger, reservation-wide strategy is being developed by the *Environmental Technician*, and EPA wetland grant funds and/or local or state funds will be sought to fund those projects.

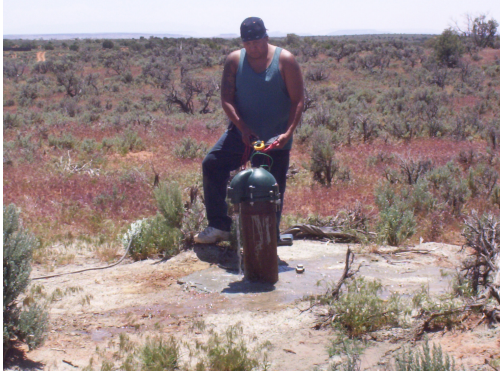
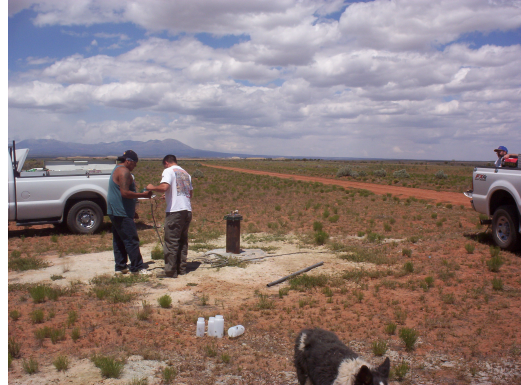
Tribal Electrical Dept. assisted in wiring pumps on White Mesa ground water monitoring wells. CWA Section 106 Special Studies \$ paid for electrical work and generator (in truck at right). Uranium mill is in background of photo on right, between well and mountains.

Various other programs have been and are being developed to address nonpoint source pollution. The Tribe's *Ground Water Protection Plan* was adopted in early 2005, and will be concurred on by EPA soon. The Ground Water Protection Plan addresses various aquifers, the pollutants and/or land use practices that may degrade the quality of the resources, and how the Tribe intends to prevent that from happening. A major component of the Ground Water Protection Plan is a pesticide management plan that describes preventative measures and how to respond to the detection of those chemicals at various levels. Another preventative measure being undertaken for the protection of ground water in Utah is a *sole-source aquifer* designation for the White Mesa, UT community drinking water aquifer. This designation will allow the Tribe to undertake more intensive preventative measures to ensure that the aquifer will meet Safe Drinking Water Act Standards. Two monitoring wells, sponsored by the Bureau of Reclamation, have been drilled into an overlying bedrock aquifer in White Mesa in order to monitor any pollution that may emanate from the White Mesa Uranium Mill, 3 miles north of the White Mesa Community of Utes. These wells will intercept any perched ground water that may be affected by the mill, indicate the level of pollution and allow a substantial time to mitigate the situation before any pollution reaches the sole-source aquifer 800-1000 feet below it.

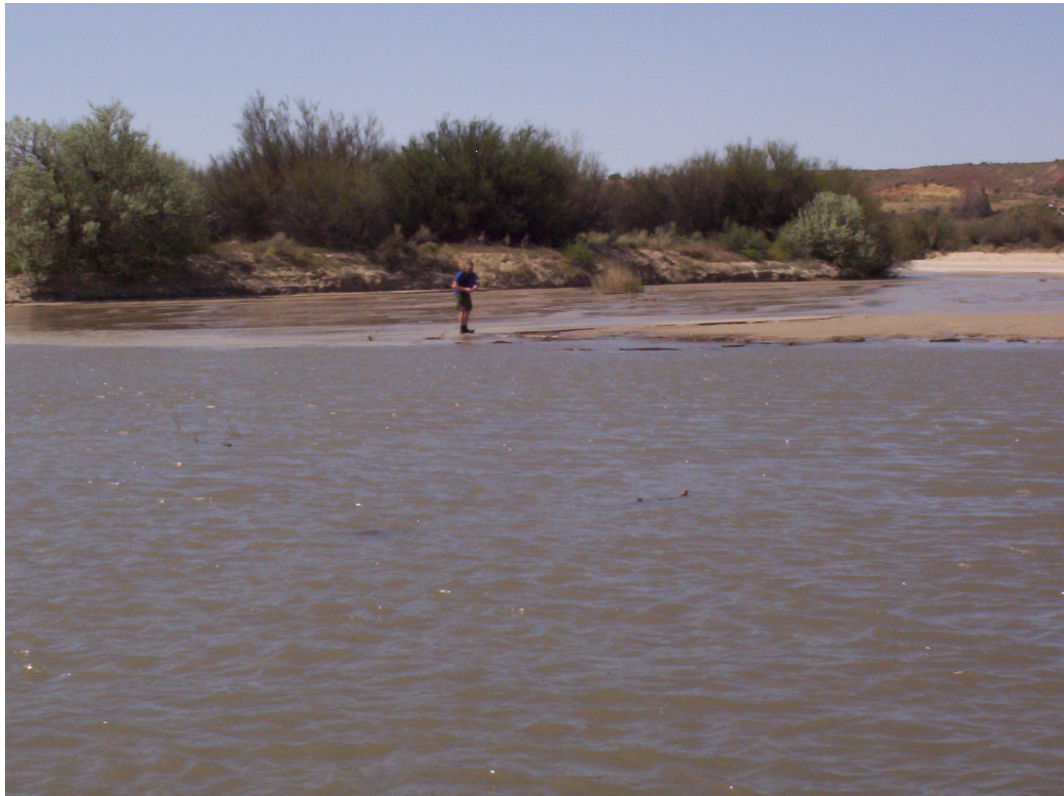
Sediment deposits from a tributary at confluence with the San Juan River, New Mexico, upstream of Ute Mountain Ute Reservation

All surface waters below an elevation of approximately 7,000 feet (and some above) on the Ute Mountain Ute Reservation have impacts from erosion and sedimentation. Channel head-cutting and stream bank instability prevent natural flooding and migration of streams and sediment deposition impacts the aquatic life habitat. Acceleration of flows from channeling for bridges, and culverts, and levying near home sites amplify the natural flashing nature of storm events in this unique geologic area. Inefficient grazing practices also dramatically added to this problem for most of the twentieth century. Once started these erosional phenomena take a monumental effort and expense to correct. When a stream is incised to a certain critical elevation, manual or mechanical restoration is the only viable option.

Total Suspended Solids (TSS) values range widely from stream to stream and depend largely on the intensity of storm events. Light rains and winter snow generally move small amounts of sediment while quick desert storms and monsoon rains often load a stream with a huge, almost instantaneous pile of sediment. The latter type of event accounts for the majority of precipitation on most of the Reservation. For example, from 1996 to 2000, San Juan River TSS levels ranged from 25 mg/L to 10,080 mg/L with a weighted-mean value of 1485 mg/L. Mancos River TSS ranged from 25 mg/L to 38,090 mg/L with a weighted-mean value of 3205 mg/L during the same time period. Navajo Wash TSS, with a much smaller watershed, ranged from 30 mg/L to 2020 mg/L with a weighted-mean of 204 mg/L.

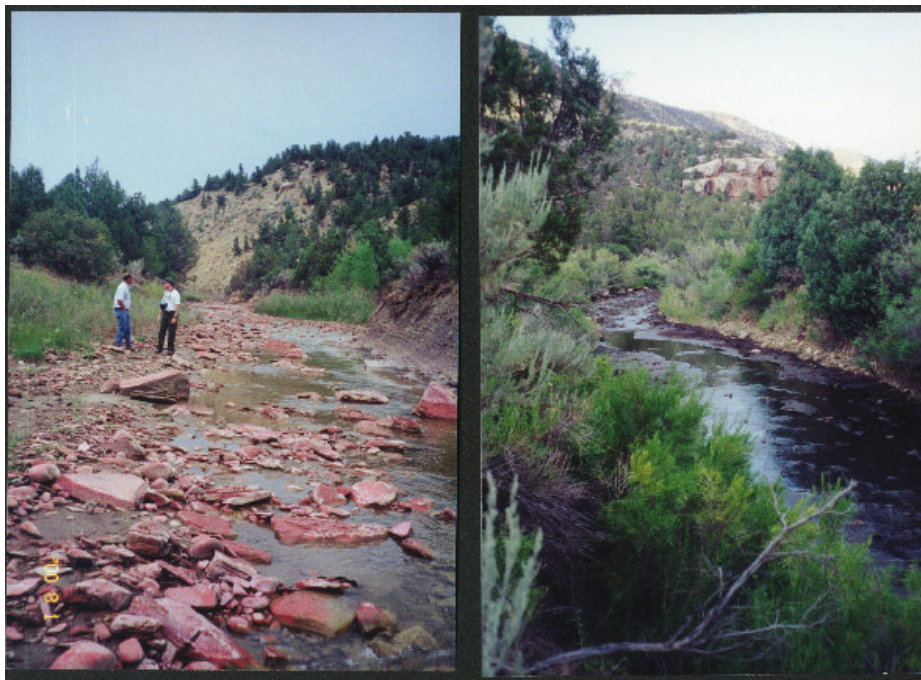
Impacts from extreme forest fires resulting from long-term fire suppression had temporary impacts to the system following the 2000 Bircher/Pony Fires. Primarily, the ashy sediment flowing from post-fire storm events suffocated cobble macroinvertebrate habitat and filled in pools that provide fish habitat. Chemical effects were minimal with detectable increases in potassium levels, slightly increased salinity and total nitrogen levels and elevated total organic carbon levels. A small fish kill was caused in Mesa Verde National Park by fire retardant being dropped in the stream, but monitoring at the site did not show detectable amounts of cyanide or ammonia, the fish toxins.

Figure 8 Forest Fire Impacts :The photograph on the left shows the site where fire retardant was dropped in the Mancos River, the photo on the right shows ashy sediment in the river following a storm event.

Macroinvertebrate data were the best indicators of the natural restoration of the ecology following the forest fires. While overall abundance of benthic macroinvertebrates was lower following the fires (total abundance decreased 75% and 95% at two sites, respectively), and sensitive species were subdued (post-fire EPT ratios at two sites were 14% and 10% compared to pre-fire means of 48% and 49% at two sites, respectively). Still, the total number of taxa, representing the overall species diversity, was consistent (7 families and 3 families post-fire compared with 7 and 5 pre-fire, respectively). It should be noted that the impact of drought on the system during the monitoring period following the fires was also a factor on the numbers. Following a rain event in September of 2003 that scoured the streambed down to cobble that had not been exposed since 1999, a huge resurgence of insects was observed—insects whose eggs had been buried for 4 years.
