RE: Pre-Construction Notification (PCN) for Nationwide Permits 3 and 43, and Request for Individual Clean Water Act Section 401 Water Quality Certification

Running Horse Pipeline MP 29 Mancos Wash Montezuma County, Colorado; Ute Mountain Ute Tribe Lands SME #200037; DA# SPK-2020-00866

# Aquatic Resources Delineation Report Running Horse Pipeline MP 29 Mancos Wash Montezuma County, CO

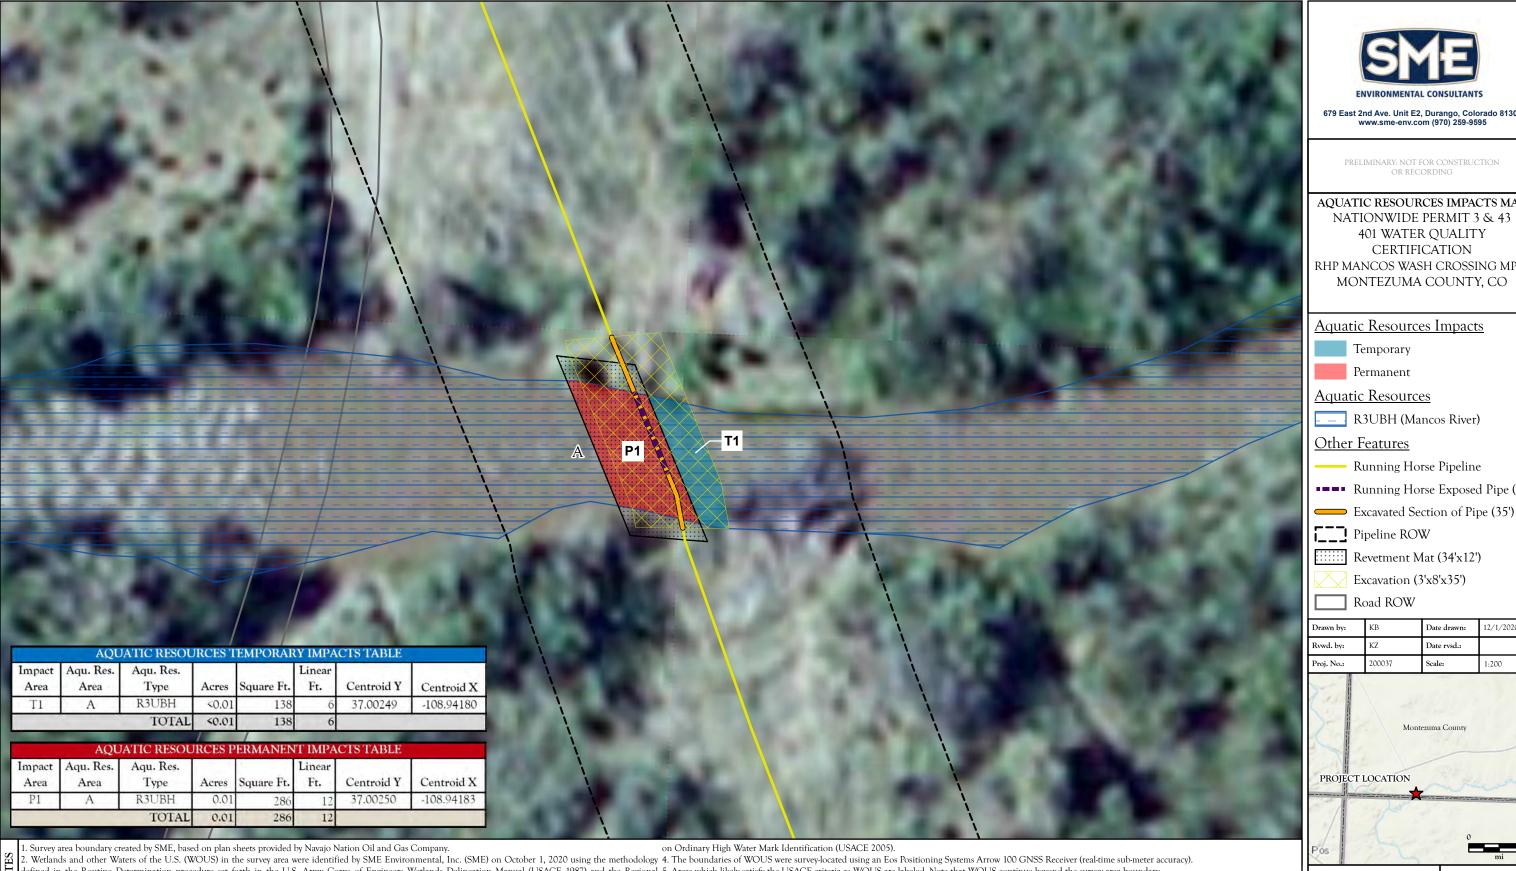
FIGURE

defined in the Routine Determination procedure set forth in the U.S. Army Corps of Engineers Wetlands Delineation Manual (USACE 1987) and the Regional 5. Areas which likely satisfy the USACE criteria as WOUS are labeled. Note that WOUS continue beyond the survey area boundary. Supplement: Arid West Region (Version 2.0). Wetland boundaries were defined based on the presence of hydrophytic vegetation, hydric soils, and hydrologic indicators 6. All WOUS boundaries, depicted hereon, are subject to modification until jurisdictional verification has been completed the USACE. that under normal conditions would indicate wetland conditions. Additionally, SME surveyed for the presence of an ordinary high water mark (OHWM) in accordance 7. Aquatic resource impact table represents acreages, square feet, linear footages and centroid locations (NAD83 State Plane) for temporary and permanent impacts with the Field Guide to the Identification of the Ordinary High Water Mark (OHWM) in the Arid West Region of the Western United States (USACE 2008) and proposed under Nationwide Permits 3 and 43. 8. Aquatic resources delineation table represents acreages, linear footage, square footage and centroid locations. egulatory Guidance Letter No. 05-05 Guidance on Ordinary High Water Mark Identification (USACE 2005).

ne Ordinary High Water Mark (OHWM) in the Arid West Region of the Western United States (USACE 2008) and Regulatory Guidance Letter No. 05-05 Guidance WOUS is not changed.

- 8. Please be aware that impacts to wetlands and other WOUS may require authorization from Local, State and/or Federal regulatory agencies. The limits of impacts to Wetland boundaries were defined based on presence of hydrophytic vegetation, hydric soils, and hydrologic indicators that under normal conditions would indicate jurisdictional wetlands and other WOUS shown hereon are based upon current development plans and renderings for submission to the USACE for Nationwide retland conditions. Additionally, SME surveyed for the presence of an ordinary high water mark (OHWM) in accordance with the Field Guide to the Identification of Permits 3 and 43 requests. Ancillary improvement types, layouts, and proposed uses may vary somewhat as long as the nature and scope of impacts to wetlands and other

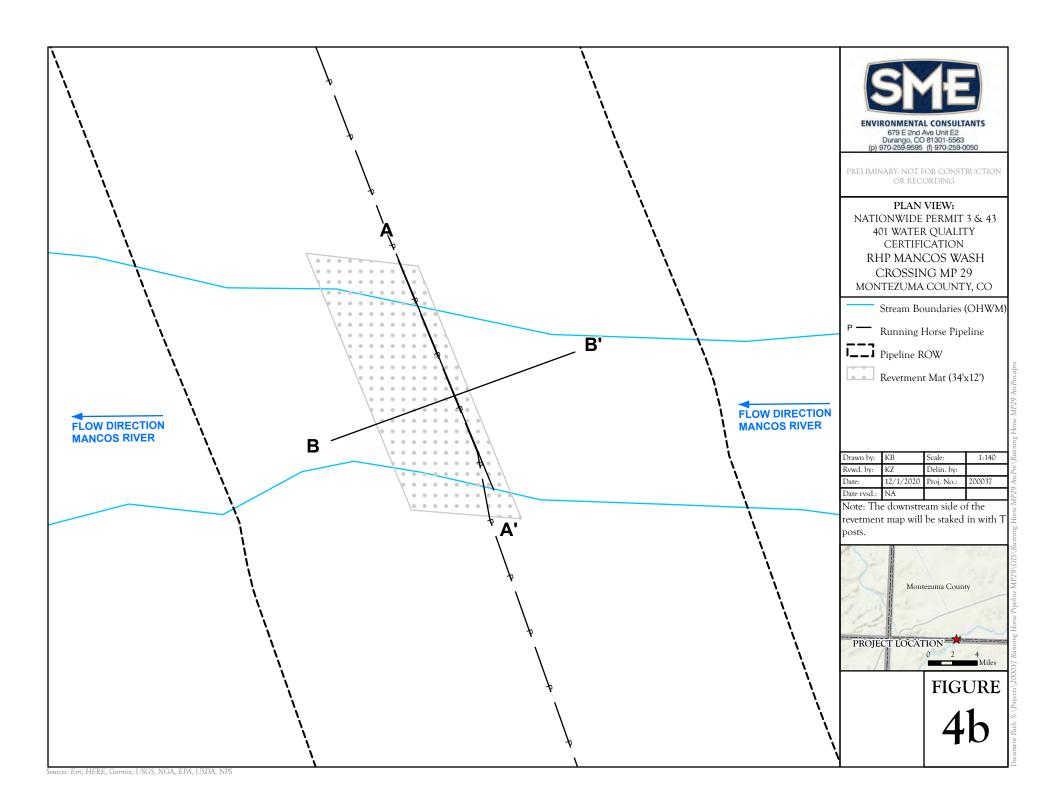
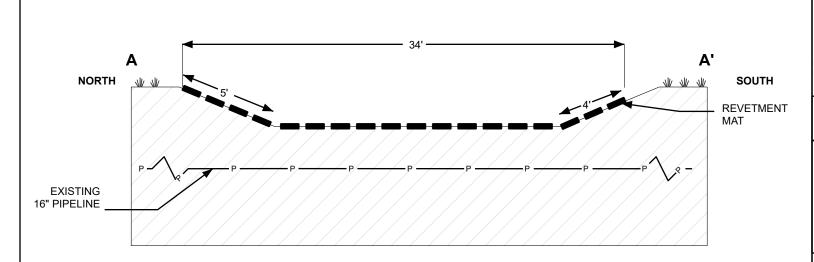
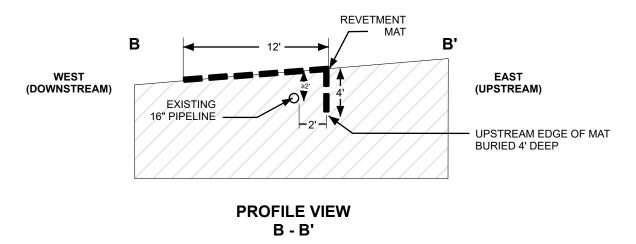
# CROSS SECTIONAL VIEW A - A'

**Project Description**. NNOGC proposes to address the immediate risk of pipeline failure by exposing the pipeline, address any corrosion concerns, re-coat the pipeline, backfill the exposed pipe and reinforce the wash with concrete revetment mats. All work is proposed to occur within the existing 50-foot pipeline right-of-way (ROW).

In stream restoration, revetments are sloping structures placed on banks or cliffs in such a way as to absorb the energy of incoming water. Many revetments are used to line the banks of freshwater rivers, lakes, and man-made reservoirs, especially to prevent damage during periods of floods or heavy seasonal rains. Many materials may be used: wooden piles, loose-piled boulders or concrete shapes. Articulating concrete revetment mats are a cost-effective, long-term solution for stream stabilization that provide a flexible alternative to riprap, gabions and rigid revetments. These flexible mats consist of 1-ft concrete blocks, spaced 6-inches apart and connected by geotextile material on one side.

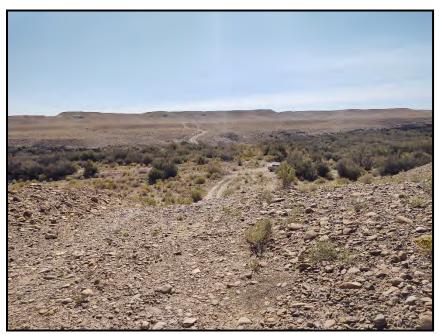
Photo Point 1 (PP1) is looking south/southeast at the rocky and primarily unvegetated upland area that characterizes the northern portion of the survey area.

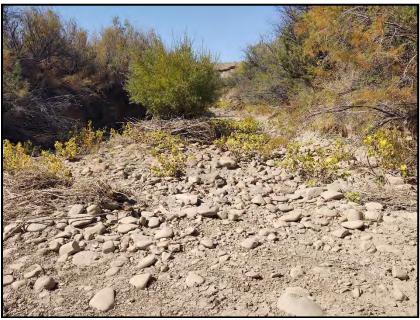
PP2 is looking west at the Manos River in the center of the survey area. The Mancos River has some vegetation growing within the channel, including Tamarisk sp. (*Tamarix sp.*) and Rough cockleburr (*Xanthium strumarium*).

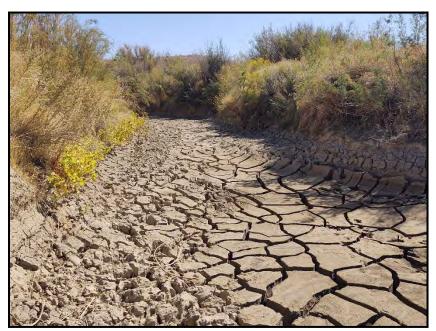
PP3 is looking east at the Mancos River channel just west east of the access road. A large storm recently deposited large amounts of sediment in this section of the channel. The Running Horse pipeline runs through this section of the river, just east of where this photo was taken (background).

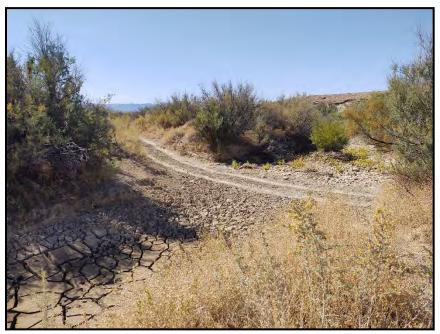
PP4 is looking southwest at where the access road crosses the Mancos River.

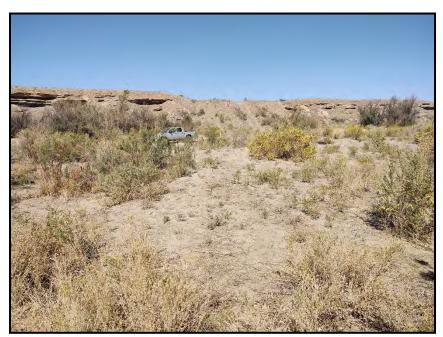
PP5 is looking north at the upland area within the right-of-way (ROW) of the Running Horse Pipeline. This area is dominated by low-lying upland herbaceous vegetation and upland shrubs.

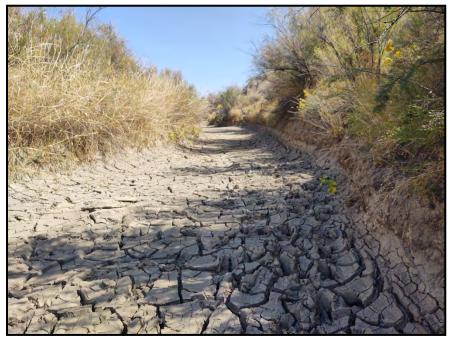
PP6 is looking east at the Mancos River, just east of the Running Horse Pipeline crossing. A large storm recently deposited large amounts of sediment in this section of the channel.

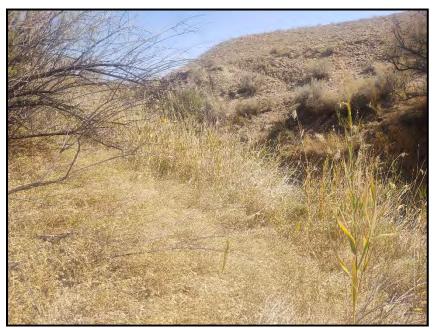
PP7 is looking southeast at a section of common reed (*Phragmites australis*) along the northern bank of the Mancos River. The bank along this section is very steep. While common reed is wetland species, no hydric soils or hydrology were present in this area, and therefore this area is not considered a wetland.
